## CASE STUDY

# Sealite Aids to Navigation Help Oil Terminal Reopen After Hurricane Dorian

*Grand Bahama Island, Bahamas*

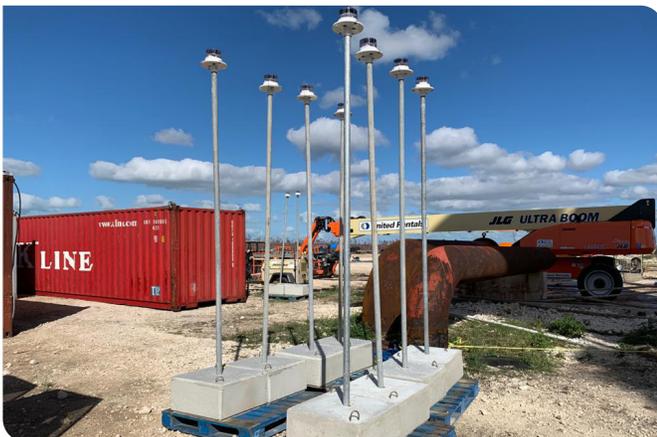
SL-60 Solar LED Marine Lanterns were positioned along the waters' edge to temporarily mark the outer channel.

Working in 104°F/40°C temperatures, driving rain, frequent water spouts, and with minimal repair equipment, the contractor re-installed two spar buoys at the channel entrance. These buoys served as a high-visibility gateway for entering vessels. SL-60 Solar LED Marine Lanterns were positioned along the waters' edge to mark the outer channel. Their 2-3NM range provided temporary marking for shallow drafted vessels until the inner channel could be charted.
